BNAS Reuse Master Plan Property Condition Assessment

Bldg. No. **29**

Name: **AUTO HOBBY SHOP**

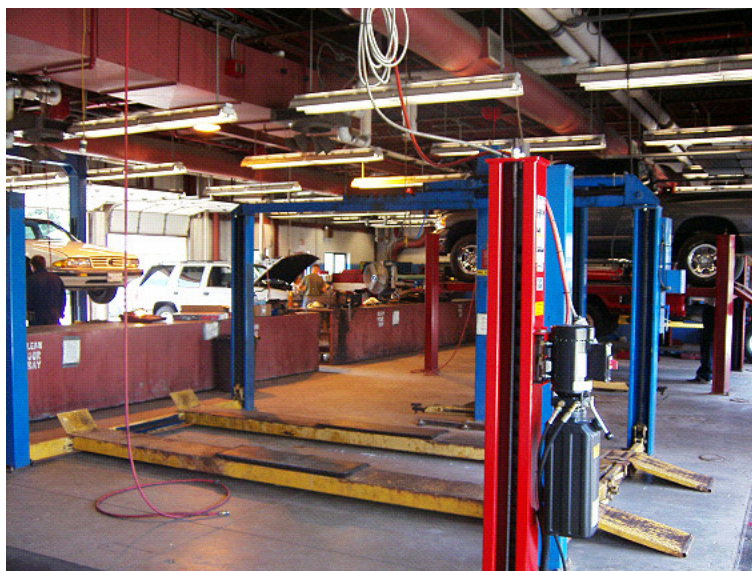
Shop Interior

Painted block walls. Some metal framed gypsum wall
board walls, painted. Fair condition, some soiling
from automotive activities in the building.
