BNAS Reuse Master Plan Property Condition Assessment

Bldg. No. **5**

Name: **MAINTENANCE HANGAR**

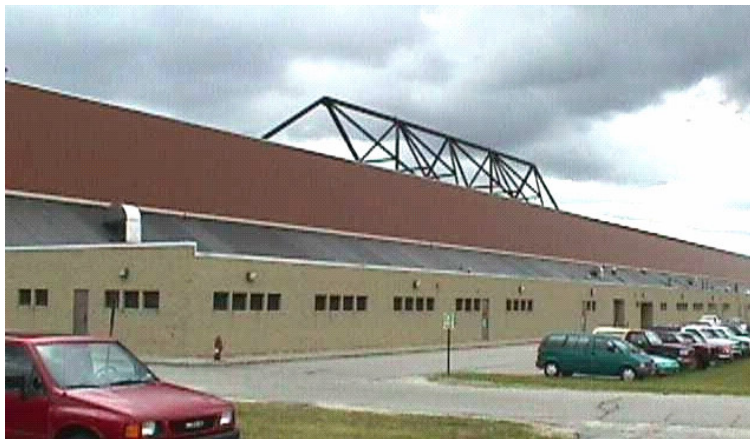
East Elevation

Exterior walls at support "lean-to" structure, CMU
cavity wall construction, 2" rigid insulation in the
cavity, Running bond split face block to 16' A.F.G.
Insulated metal panels above 16', Fair condition:
failed sealants in exterior walls, Exterior walls at
hanger, CMU backup wall tied to steel structure
Split face exterior cladding to 16' A.F.G., 2"
preformed insulated metal siding above 16'
Good condition: some oil canning present in metal
siding.

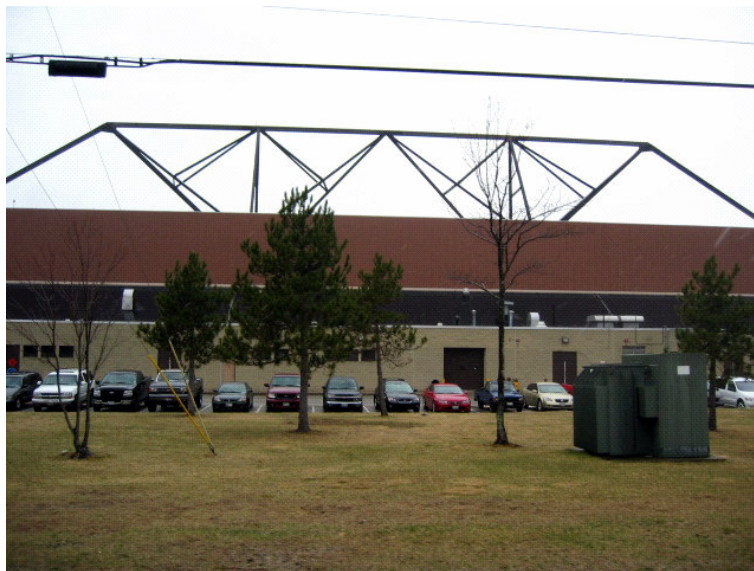
East Elevation

No curb cuts at entrances from parking lots.
