BNAS Reuse Master Plan Property Condition Assessment

Bldg. No. **25**

Name: **INDOOR FITNESS CENTER**

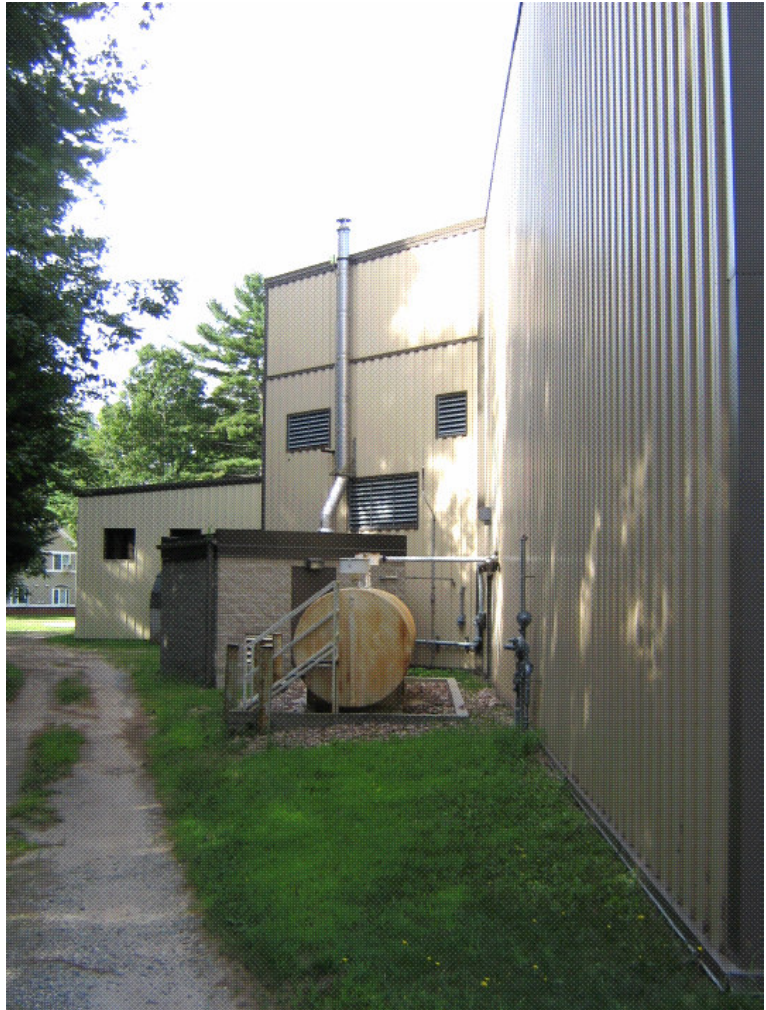
South Elevation

Trees adjacent to building are overgrown. Hitting siding of building. Roof requires cleaning of pine needle debris, repainting of flashing elements.

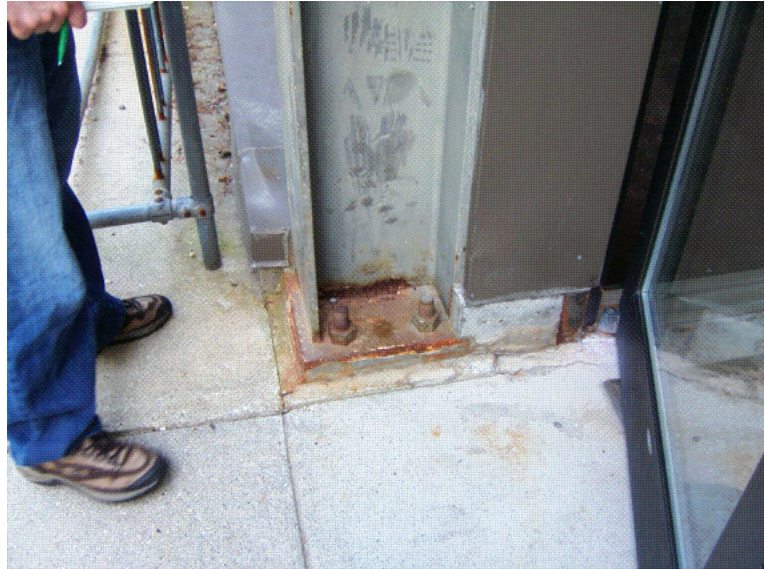
Exterior Steel Braced Frames are exposed with rust but no heavy section loss yet. Repaint.

Column bases at main entrance

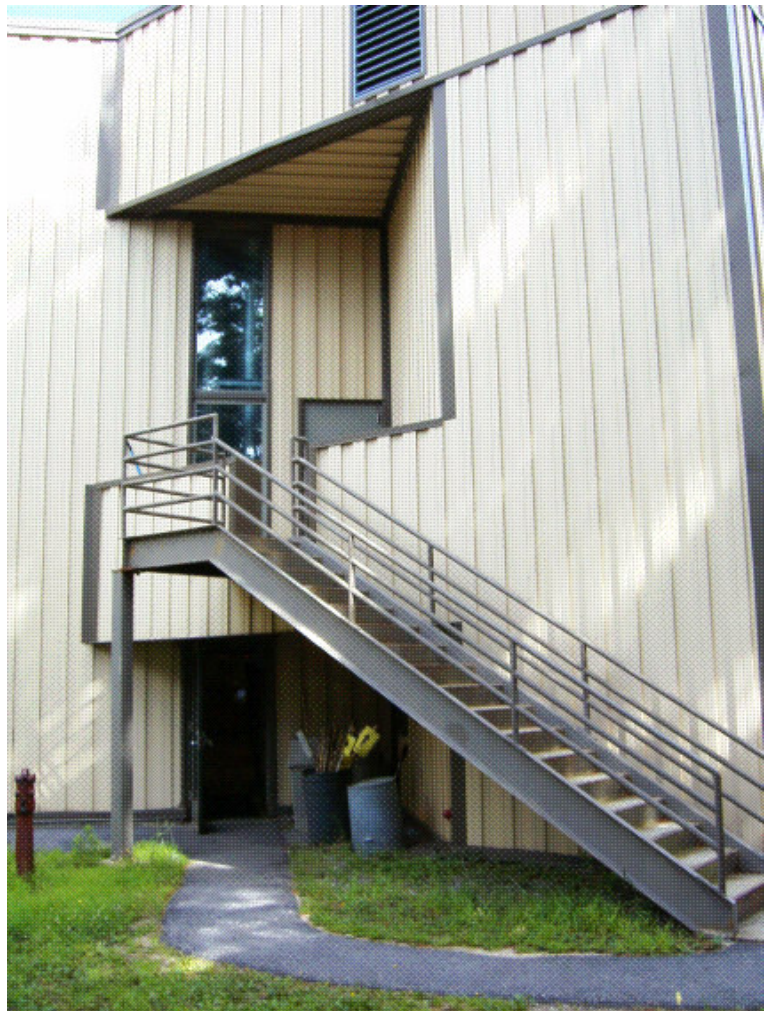
Stair towers in building are enclosed with one hour rated construction. Mezzanine stairs are not. IBC will require these stairs to be enclosed.

Egress stair at South elevation
