BNAS Reuse Master Plan Property Condition Assessment

Bldg. No. **223**

Name: **NMCI BUILDING**

Current Use: **COMM. OFFICES
(FORMER ARMORY)**

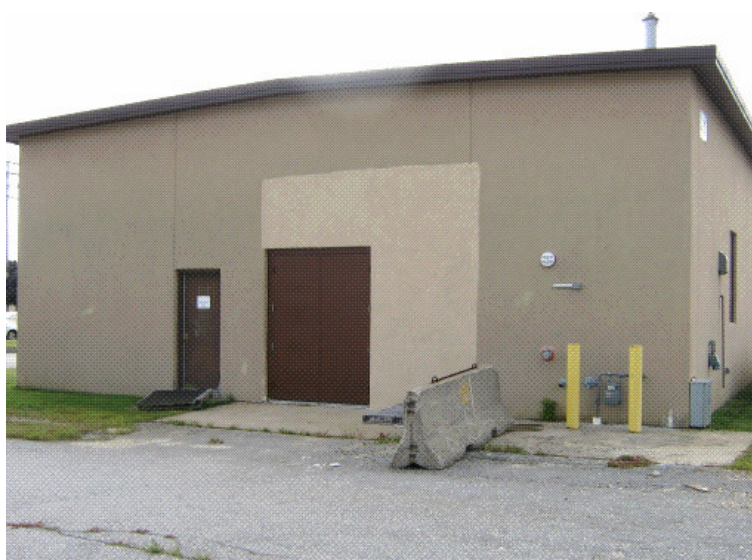
East Elevation

Site appears to drain away from building on all sides except for East side. Grades on this side are slightly above finish floor elevation.
