# BNAS Reuse Master Plan Property Condition Assessment

Bldg. No. **590**

Name: **TRANSPORTATION MAINT. SHOPS**

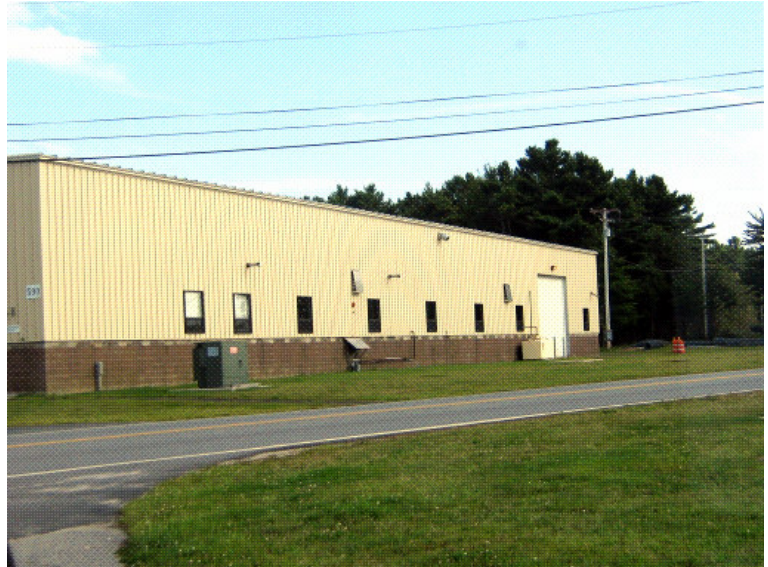
West Elevation

Natural gas metering (fuel supply ) located at West elevation of building.
